FIVE-YEAR REVIEW REPORT

**ATLAS ASBESTOS MINE SUPERFUND SITE
AND
COALINGA ASBESTOS MINE SUPERFUND SITE
FRESNO COUNTY, CALIFORNIA**

August 3, 2011

**PREPARED BY:
US ENVIRONMENTAL PROTECTION AGENCY
REGION 9
SAN FRANCISCO, CA**

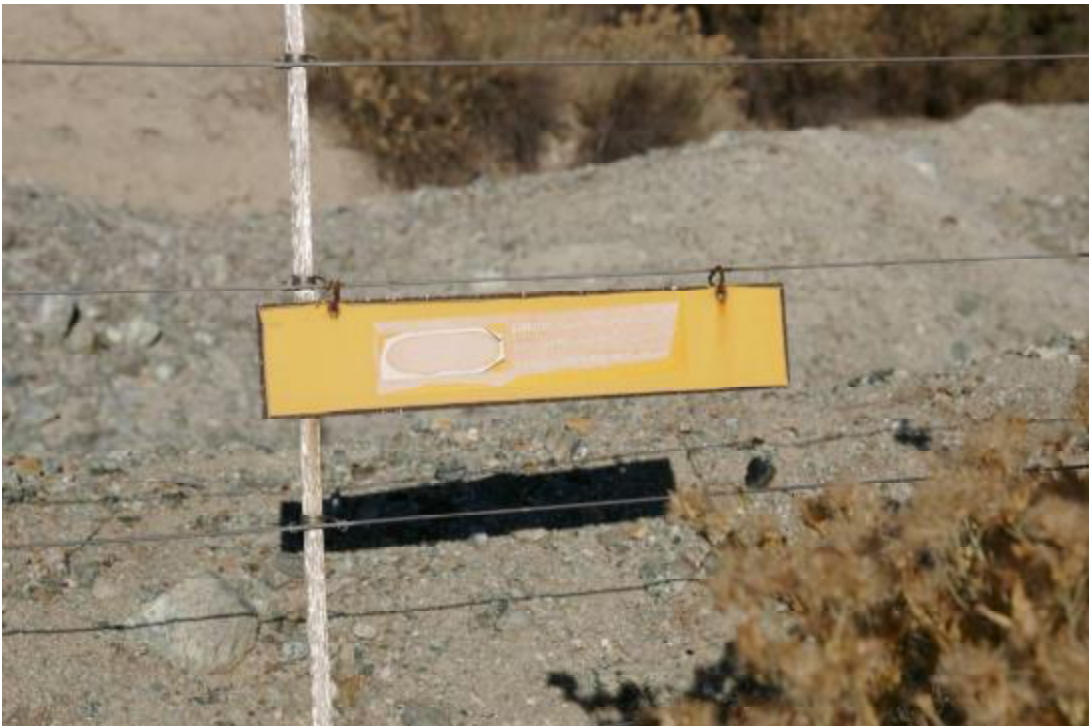
Fencing outside Pond C. The sign should read “ASBESTOS – Cancer and lung disease hazard, authorized personnel only, respirators and protective clothing required in this area.” This represents one of the most heavily weathered signs on the site.

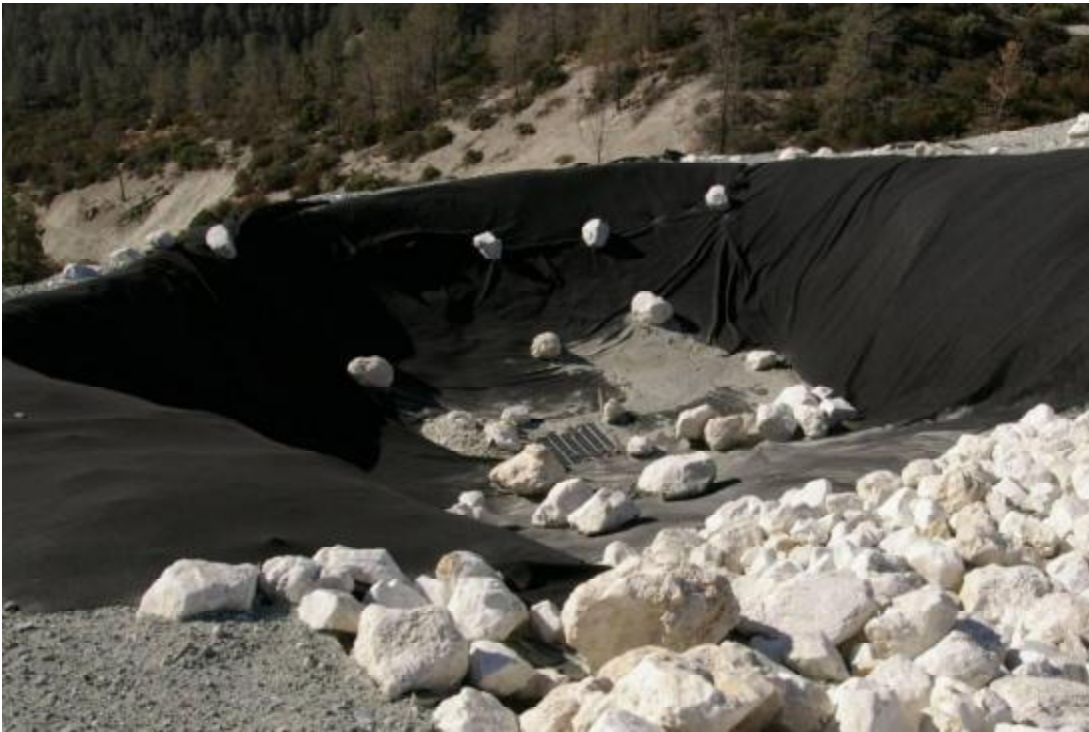
Gully on southern face of tailings pile, repaired during 2005 maintenance. Surface water is conveyed down the tailings pile through subsurface piping via the surface water catchment shown in the photograph. Drain rock and berms are intended to limit erosion in this area.

- Repair four gullies on the outboard slope of the tailings pile south of the Regional Sediment Storage Area (RSSA)
- Repair the eroded area near the culvert on the road to Rover Pit
- Stabilize the Channel A terminus

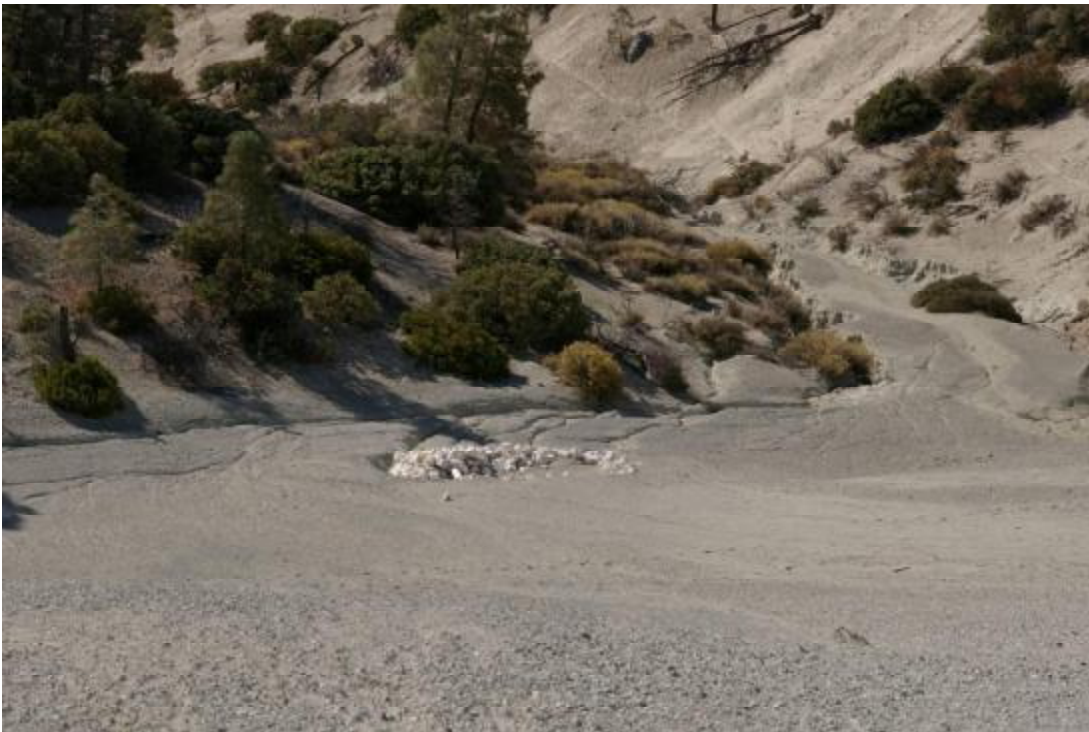
Rills extend downstream from the outlet of the subsurface piping at the bottom of the tailings pile.

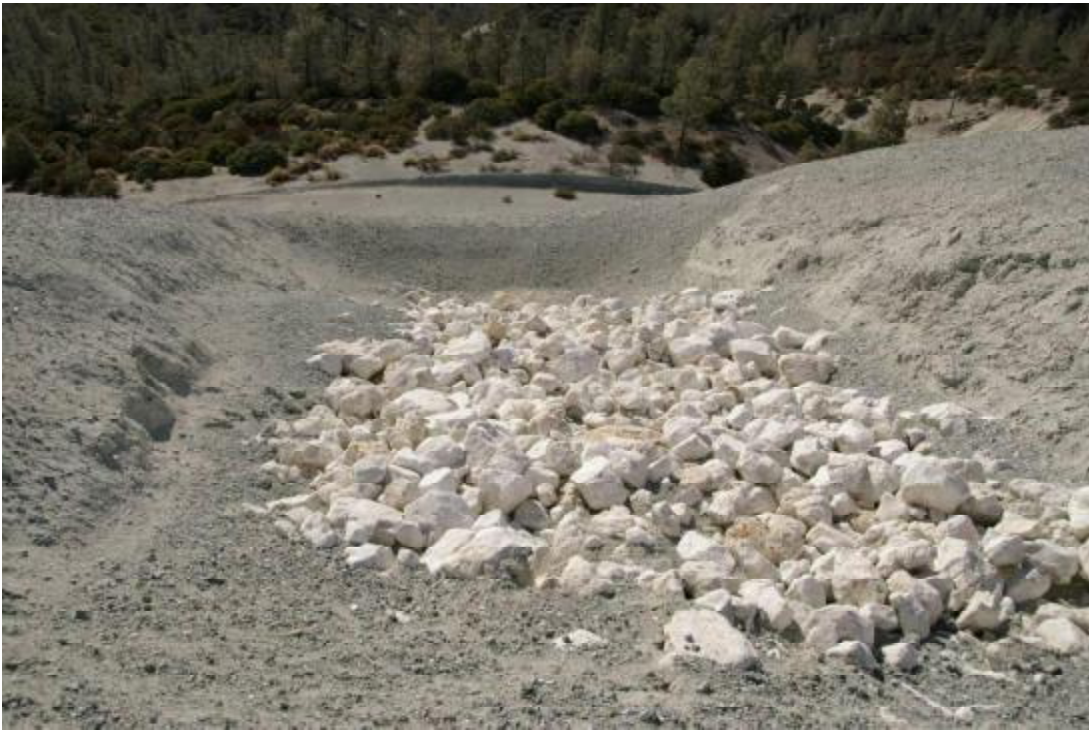
Drain rock installed during 2005 maintenance to prevent erosion from occurring on the southern face of the tailings pile.

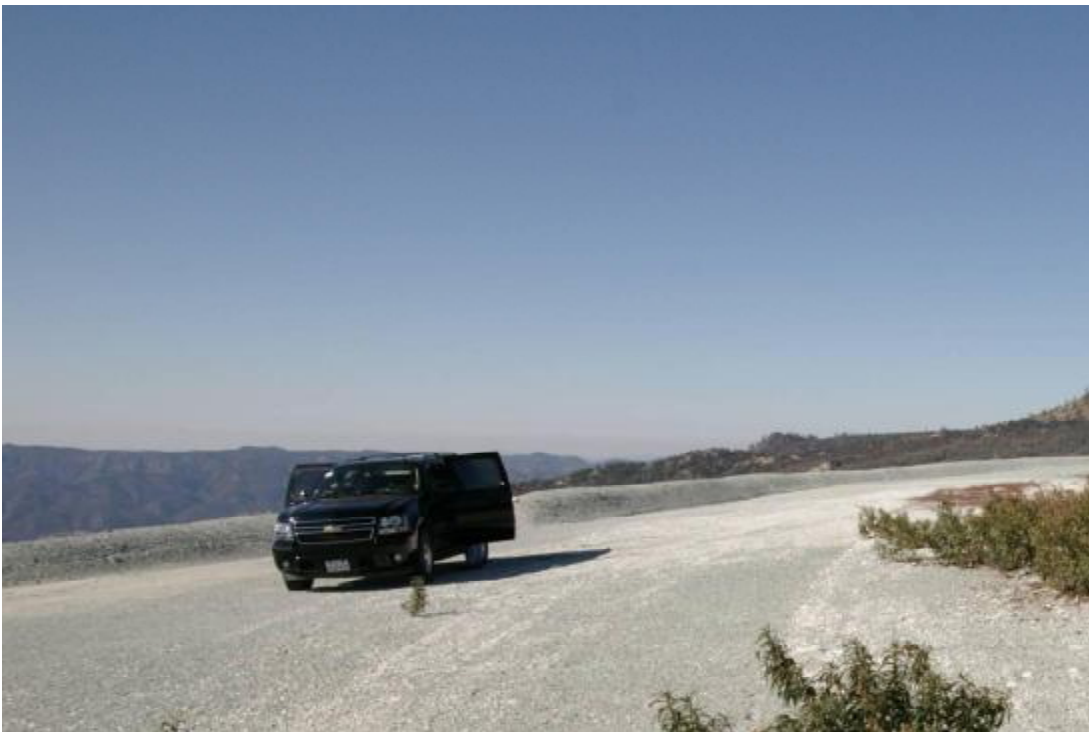
Berm (behind vehicle) installed south of the Regional Sediment Storage Area to limit erosion.

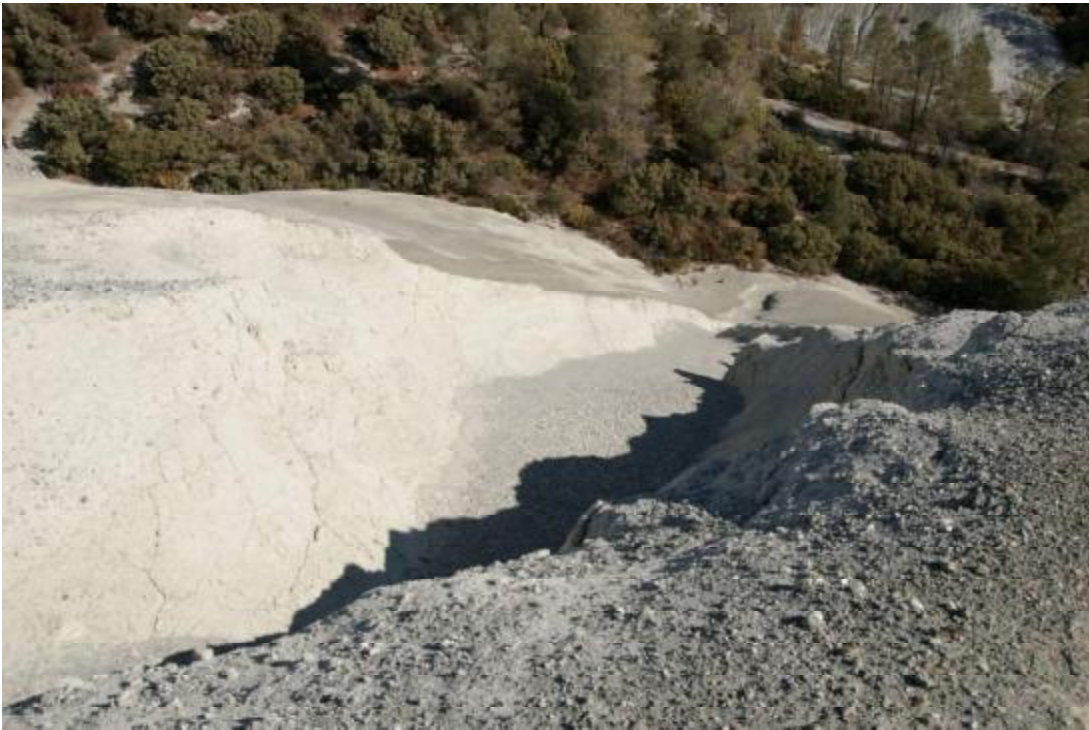
Gully on eastern slope of the tailings pile. Channel B can be seen in the upper right in the background.

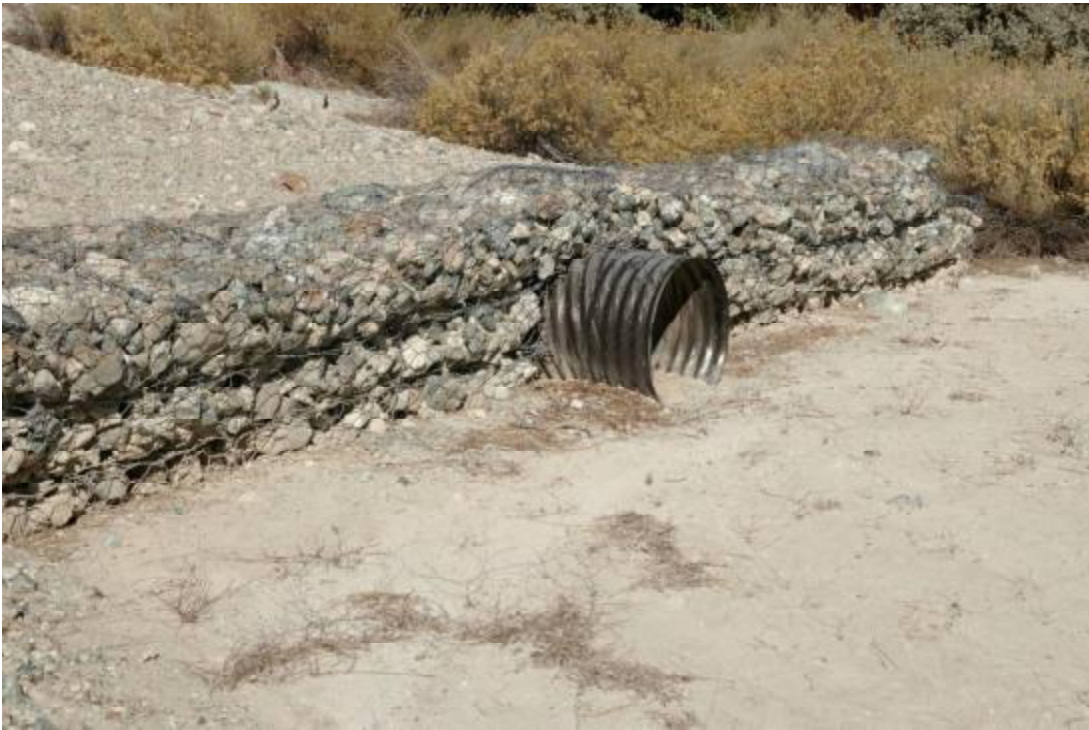
Sediment trap area at the discharge outlet of Pond G, upstream of Channel B. No sediment buildup was observed in the outlet.

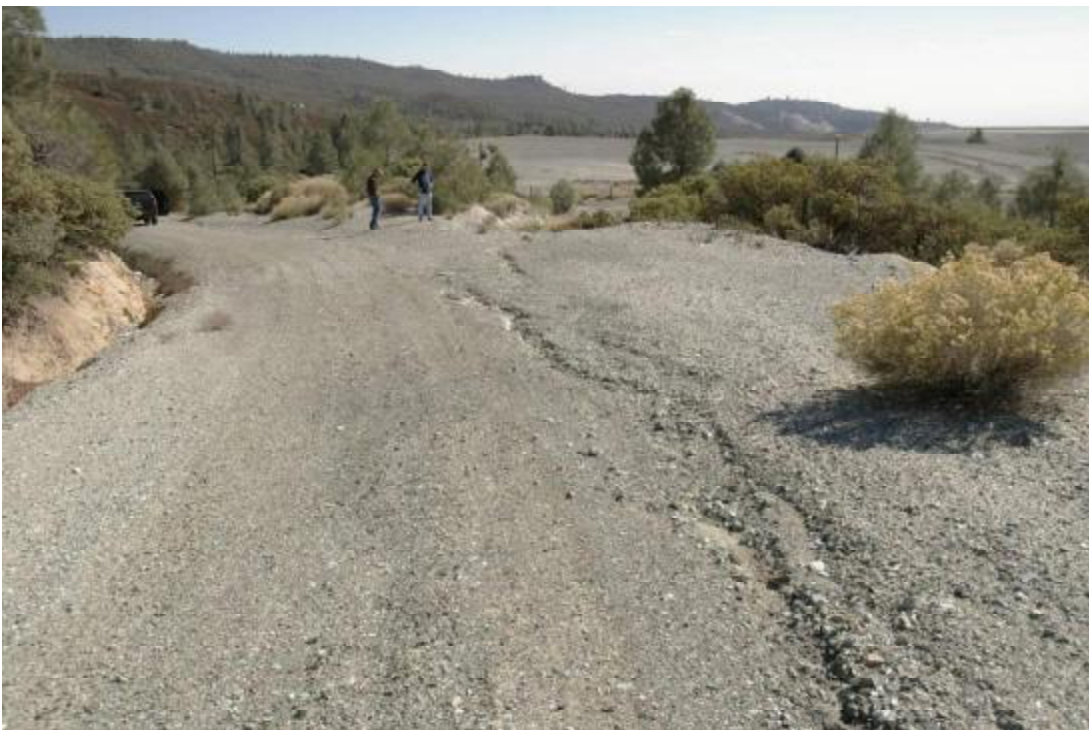
Erosion along southern side of road extending to Pond A.

- Road to Pond A: Minor erosion on the outboard side of the road was observed. It was recommended that the roadway and shoulder be regarded to redirect storm water runoff to a gully on the south side of the road. In addition, sediments should be cleaned from the culvert at the base of the road to Pond A near its intersection with the paved roadway west of Pond D.

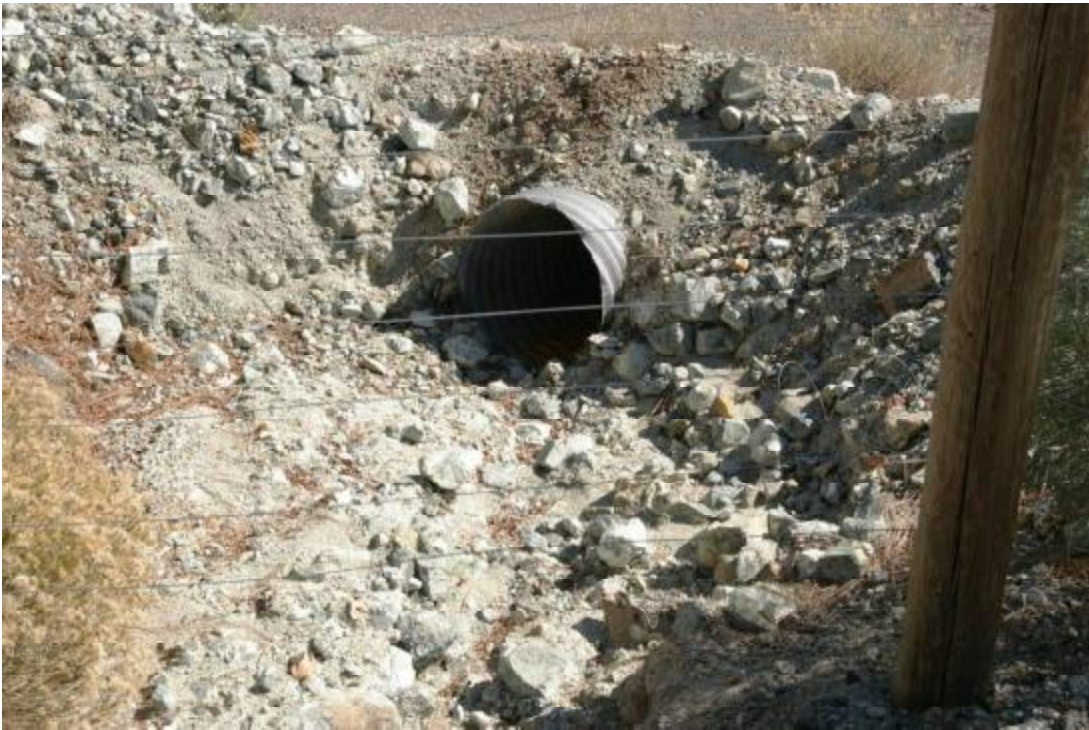
Culvert at the end of the drainage channel along access road to Pond A. The inlet was cleared of sediment and vegetation after the previous five-year review and has not re-accumulated.

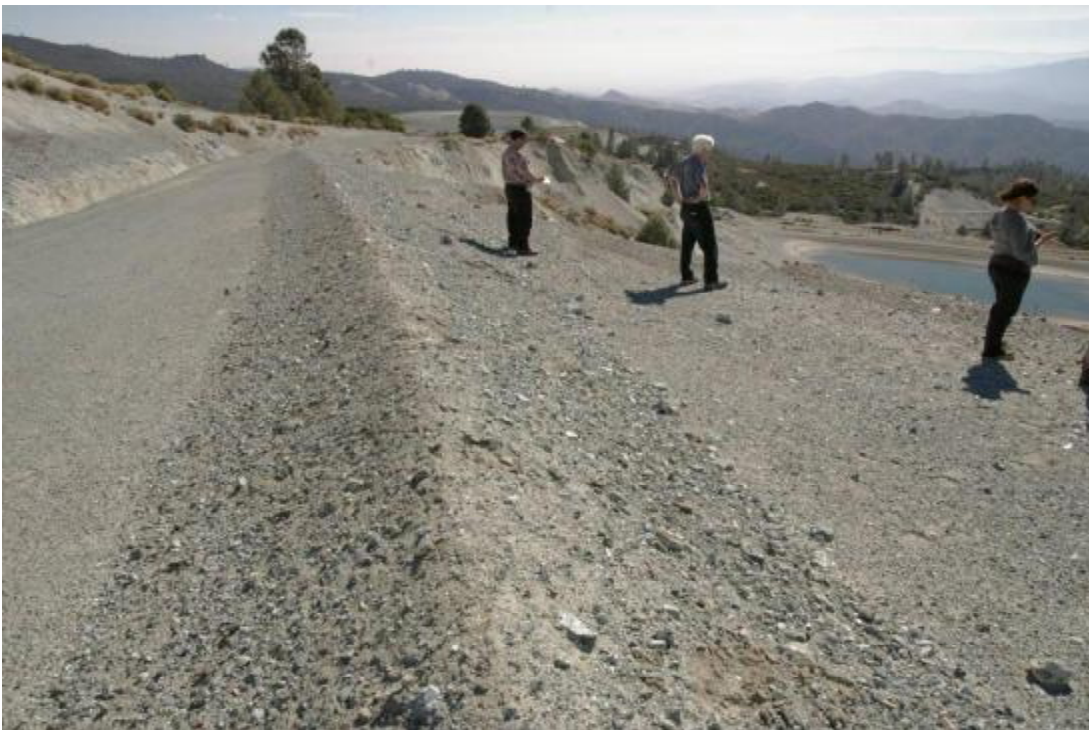
Berm installed along the access road to Pond A to limit erosion on the highwall slope above Pond B.

- Road to Pond A: The high-wall slop above Pond B continues to slough. To reduce the potential for high-wall slope failure, it was recommended that measures be undertaken to prevent runoff on the Road to Pond A from flowing over the Pond B high-wall. Also, it was recommended that debris in the adjacent drainage ditch be removed to prevent ponding in the vicinity of the high-wall.

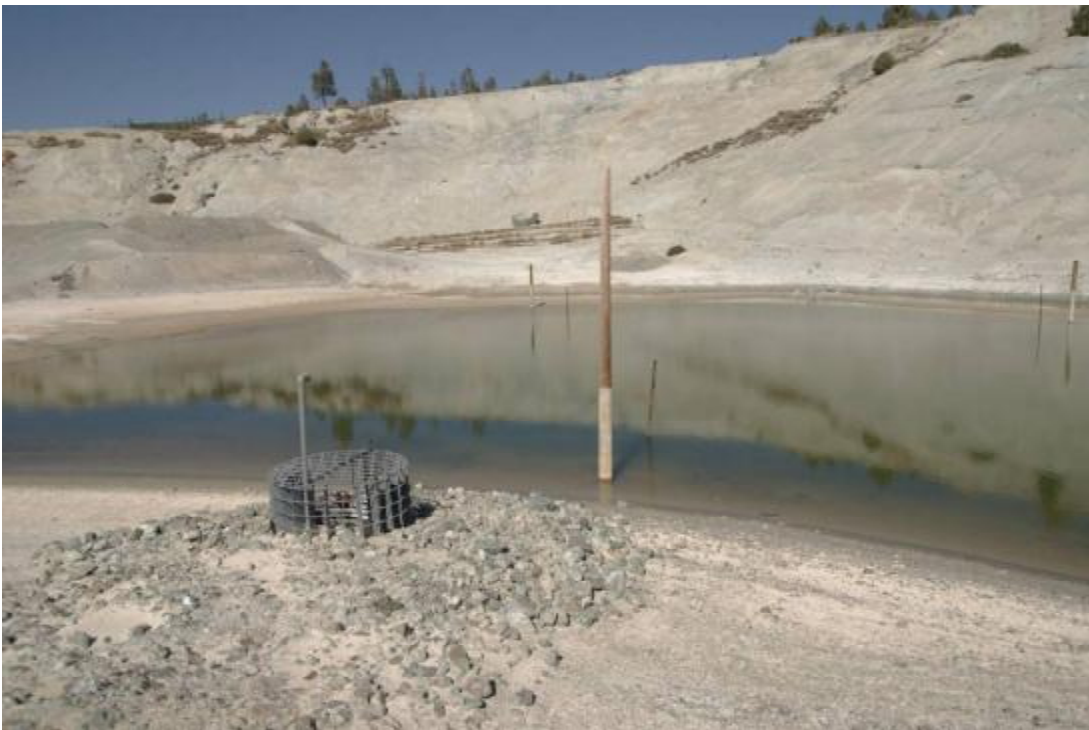
Pond B showing drain inlet and sediment depth indicator pole. The Sediment Storage Area at Pond B is seen in the background (left side of the photograph).

- Sediment Removal from Pond B: Because of sediment accumulation over the years, the storage capacity of Pond B has been reduced. As a result, it was recommended that accumulated sediments be removed from Pond B.

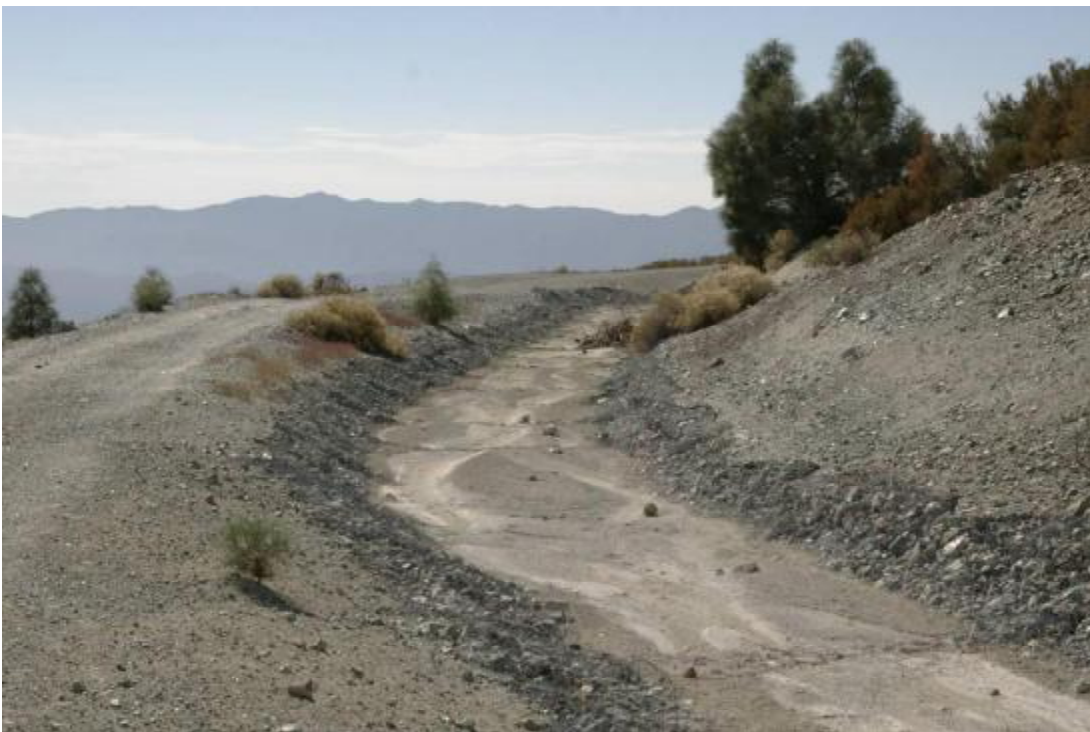
Channel A. Sedimentation has filled the rock mattresses in the channel bottom, creating a smooth surface.

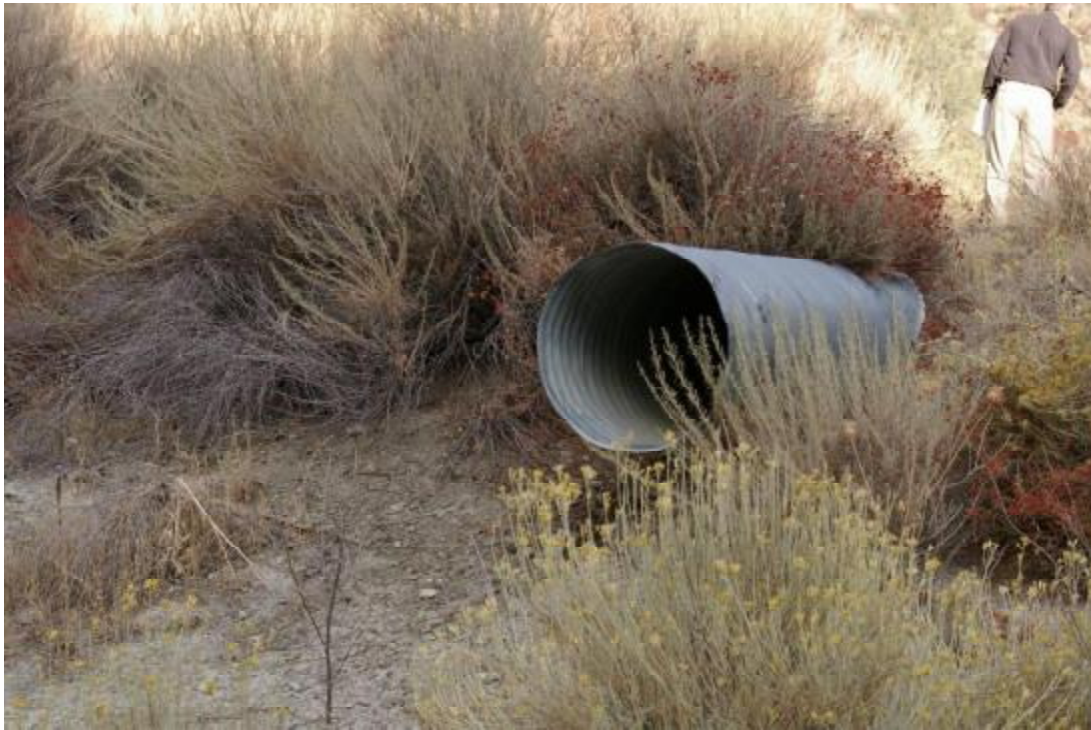
The outlet pipe is free of debris and sediment.

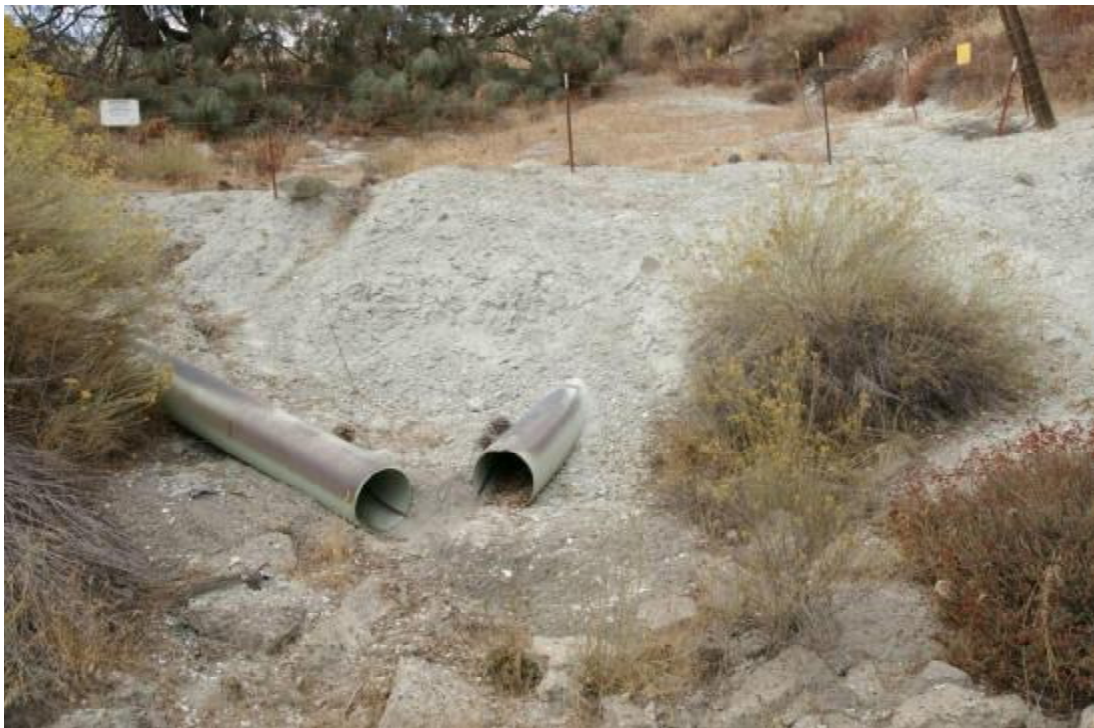
Tailings pile drainage outlets at the Energy Dissipation Pond showing minor debris accumulation in pipe outlet.

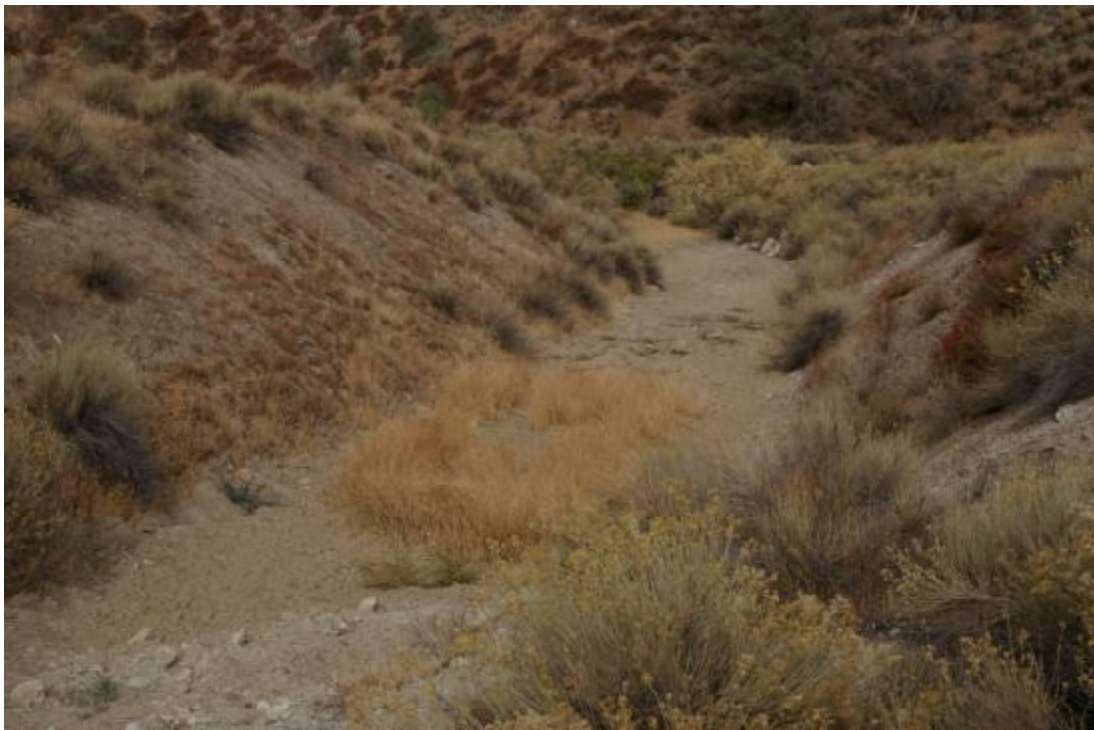
Area in the Cross-Canyon Stream Diversion channel where standing water was observed during 2006 inspection. The area is now dry.

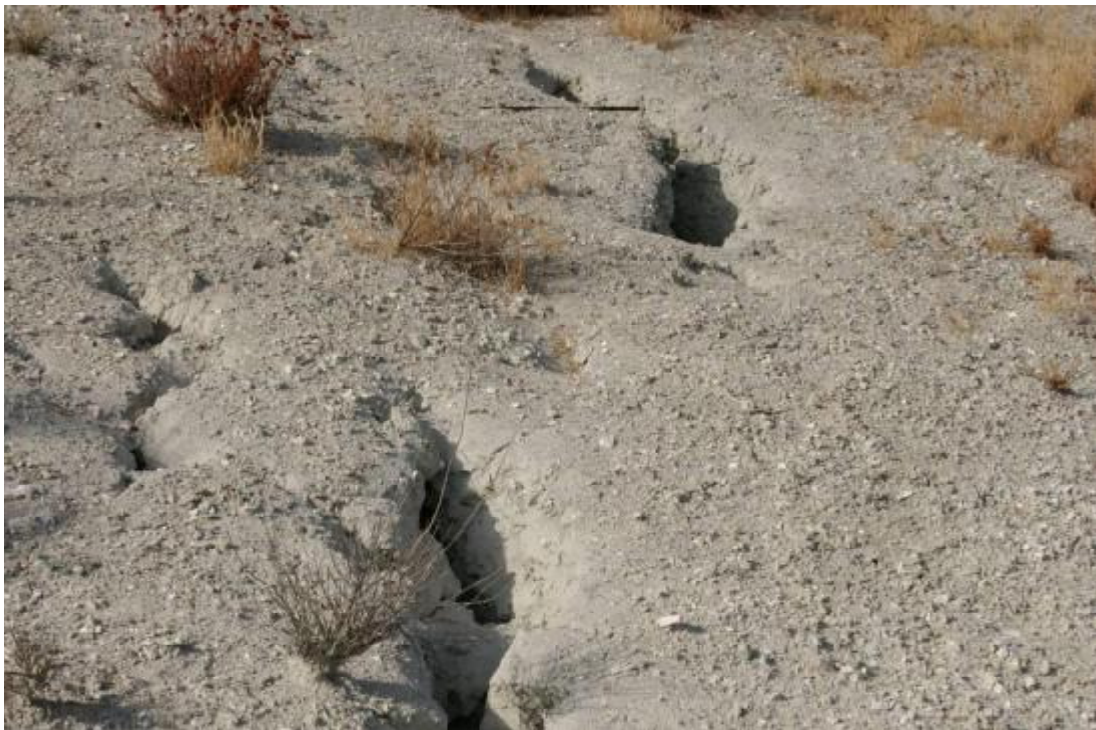
Example of large desiccation cracks on the tailings pile.

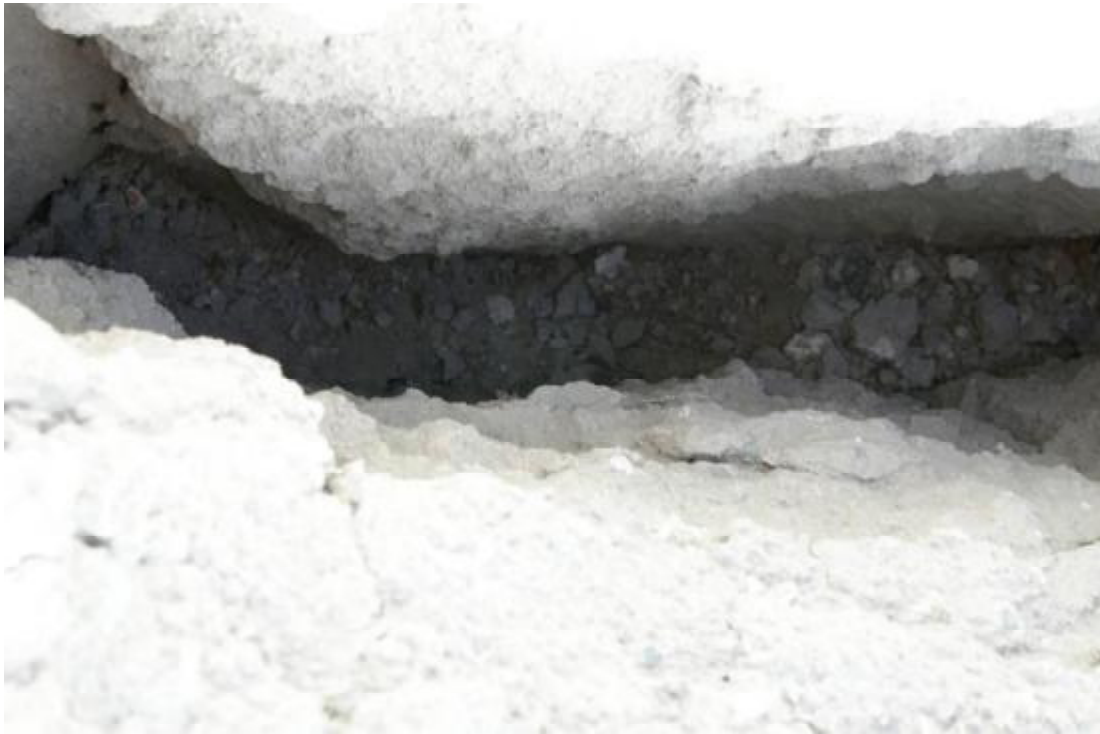
Close-up view of a large desiccation crack on the tailings pile.

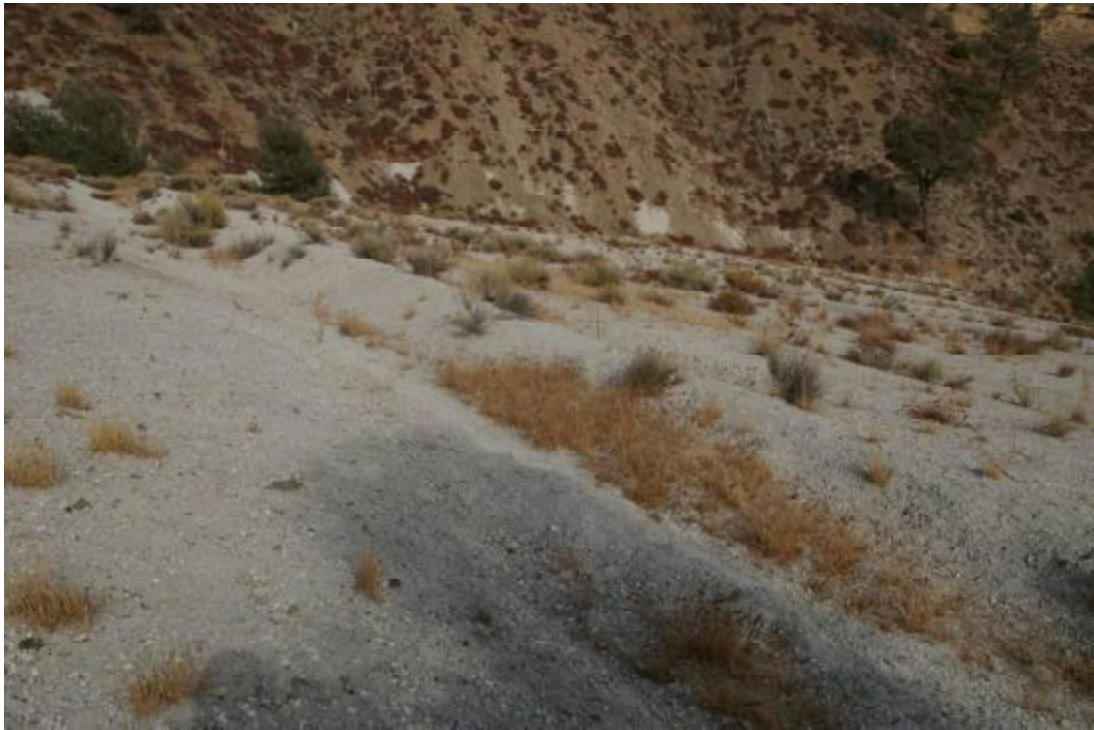
V-ditches on the tailings pile for collecting surface water runoff. Runoff drains through subsurface piping to the Energy Dissipation Pond via drainage inlets.

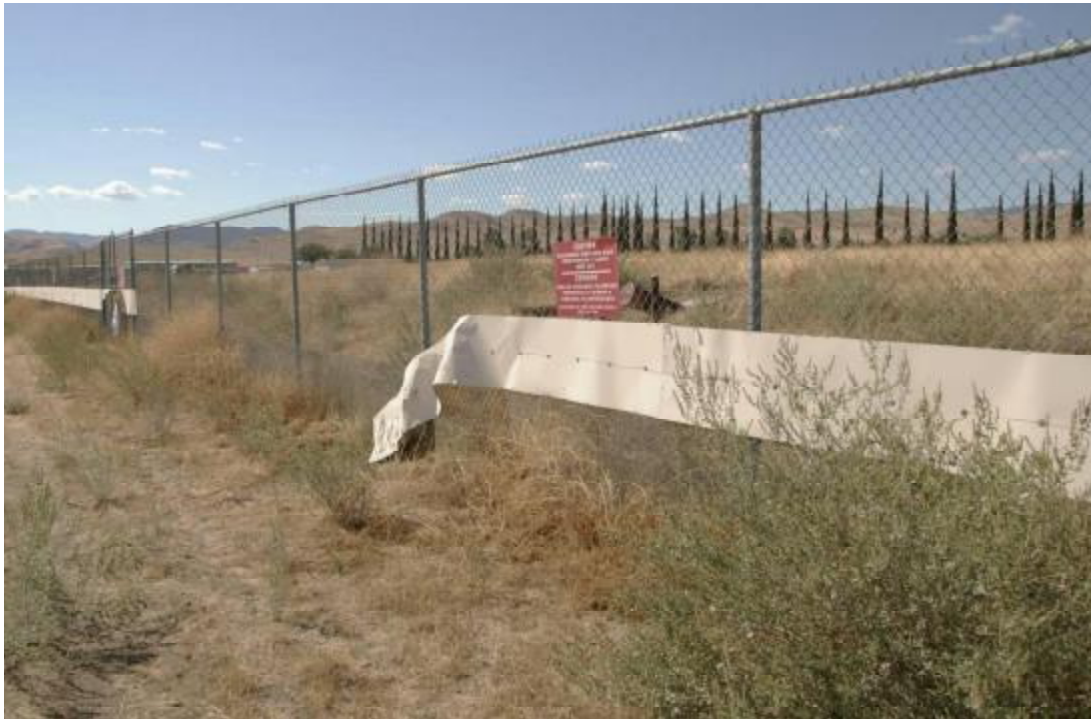
Fencing surrounding the Waste Management Unit. Fence material with a smaller screen size was installed across the base of the fence to prevent burrowing animals from entering the site.

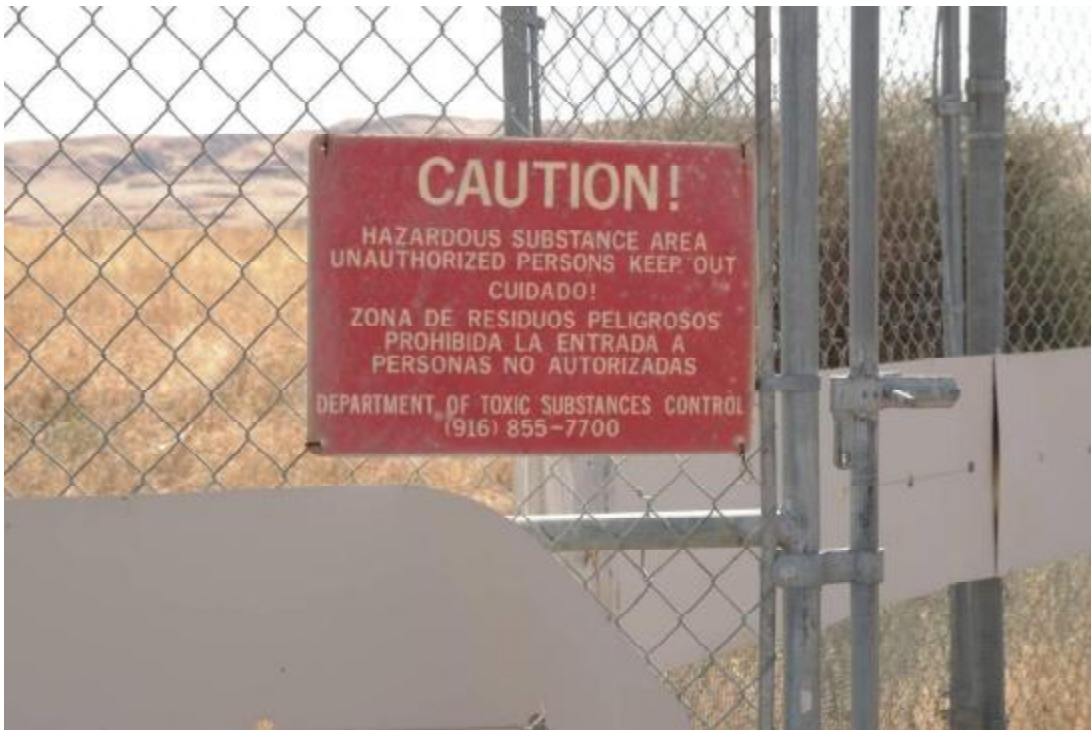
Warning sign posted on fence surrounding the site. The DTSC contact phone number presented on this sign is no longer valid. Access to the Waste Management Unit is restricted by a locked gate.

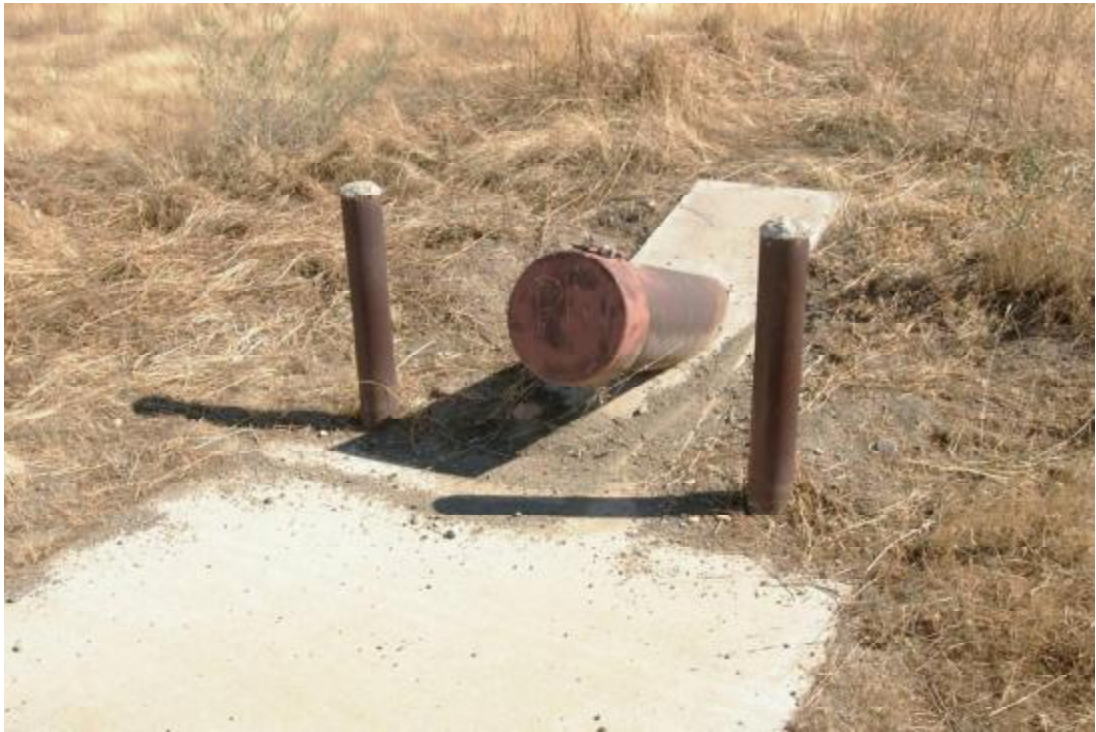
Neutron probe access tube previously monitored to assess moisture content in soil vapor beneath the cap.

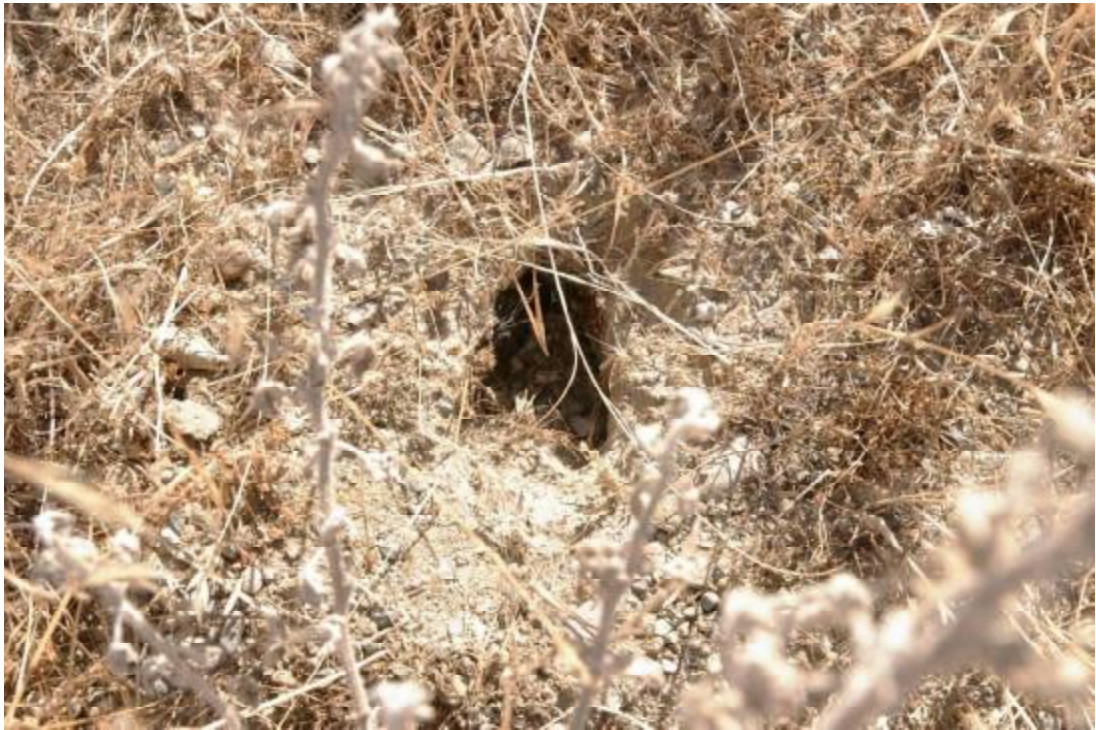
Hole in cap created by burrowing animals.

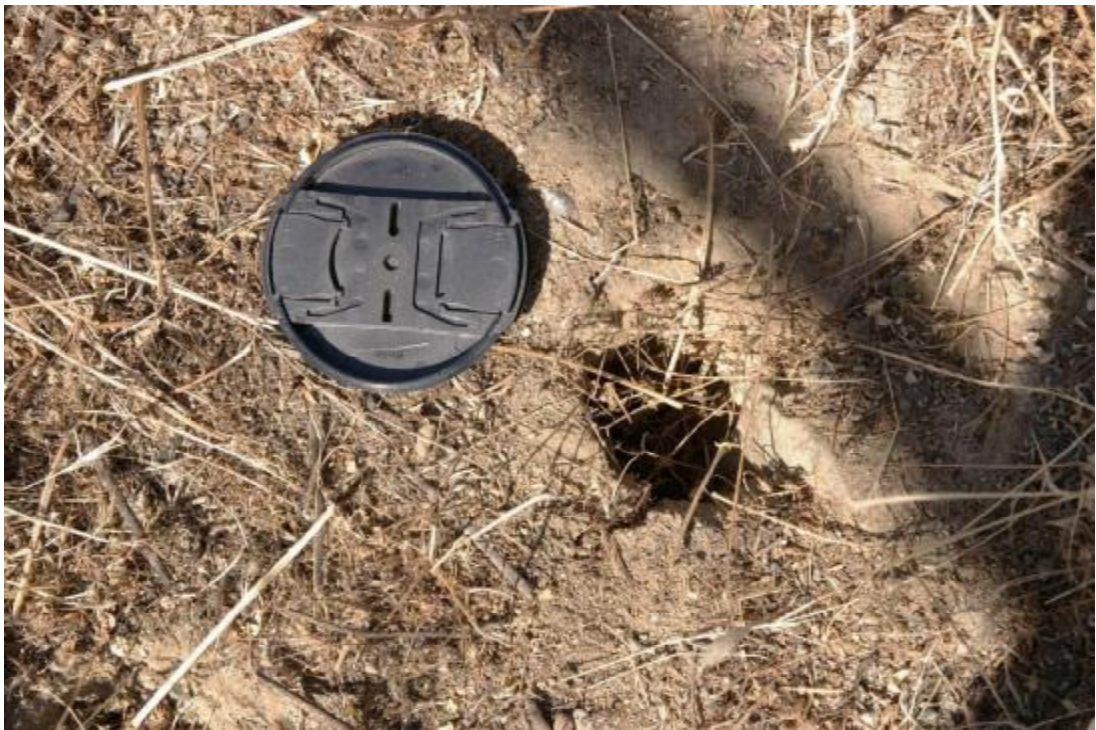
Hole near base of cap created by burrowing animals. The lens cap included for scale is 67mm in diameter.

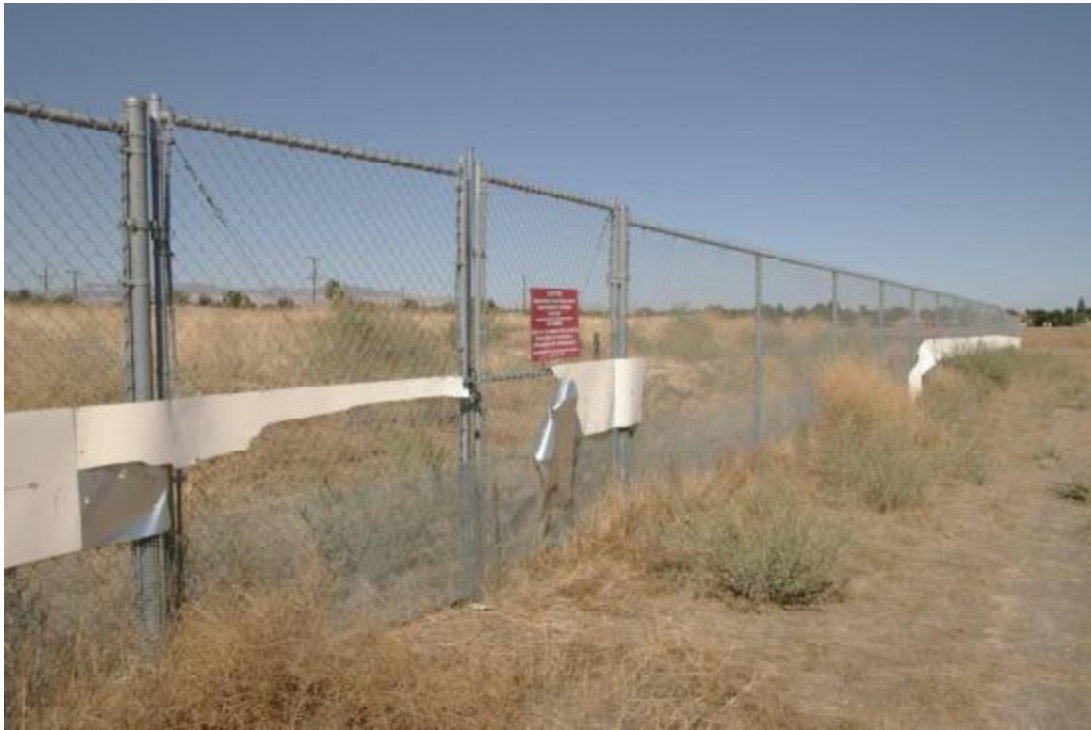
Animal exclusion sheeting is damaged on perimeter fence. Shrubby weed growth has accumulated around perimeter fence.

D. Opportunities for Optimization			
Describe possible opportunities for optimization in monitoring tasks or the operation of the remedy. <u>The following optimization and maintenance activities should be performed: Signage update or replacement, pest and burrow eradication, pest exclusion structure repair, and weed abatement.</u>
